## Asbestos Register

Town Hall, Hughes Street, Denham

Updated 18<sup>th</sup> October, 2018 - WJD

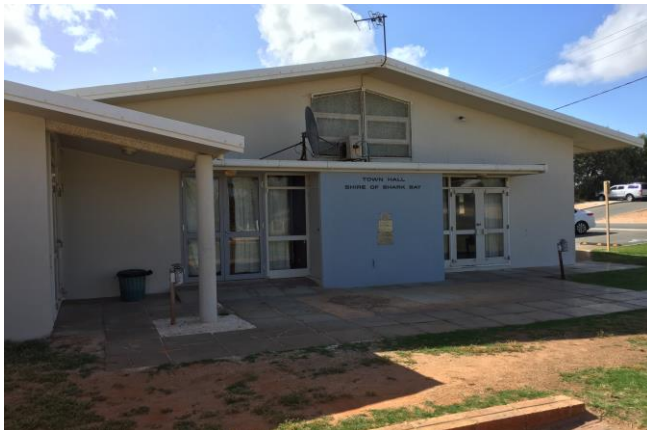
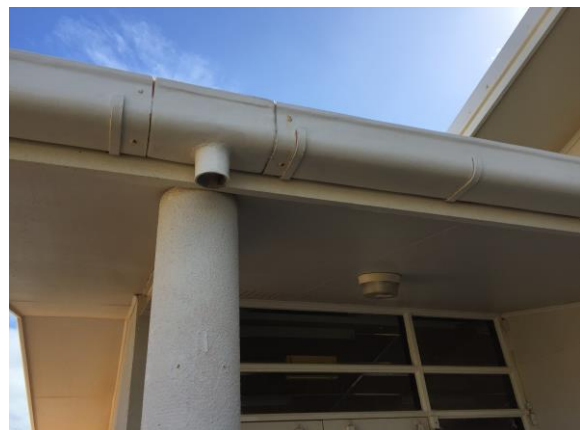
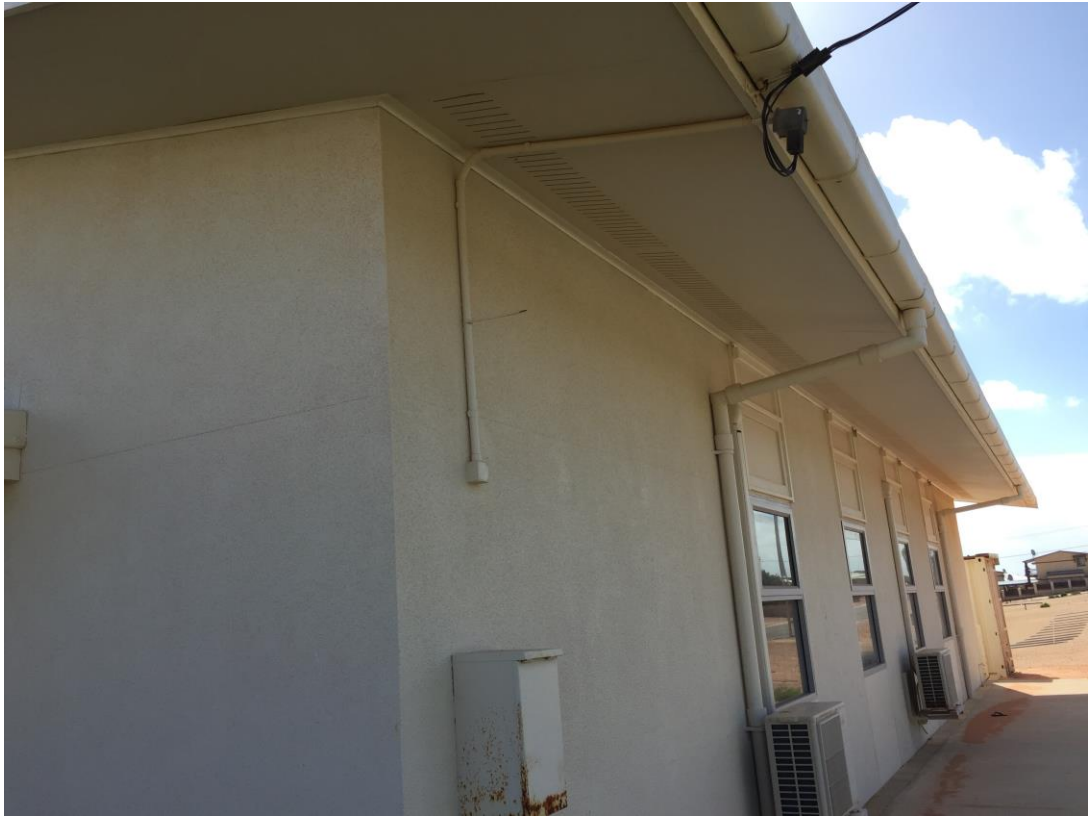
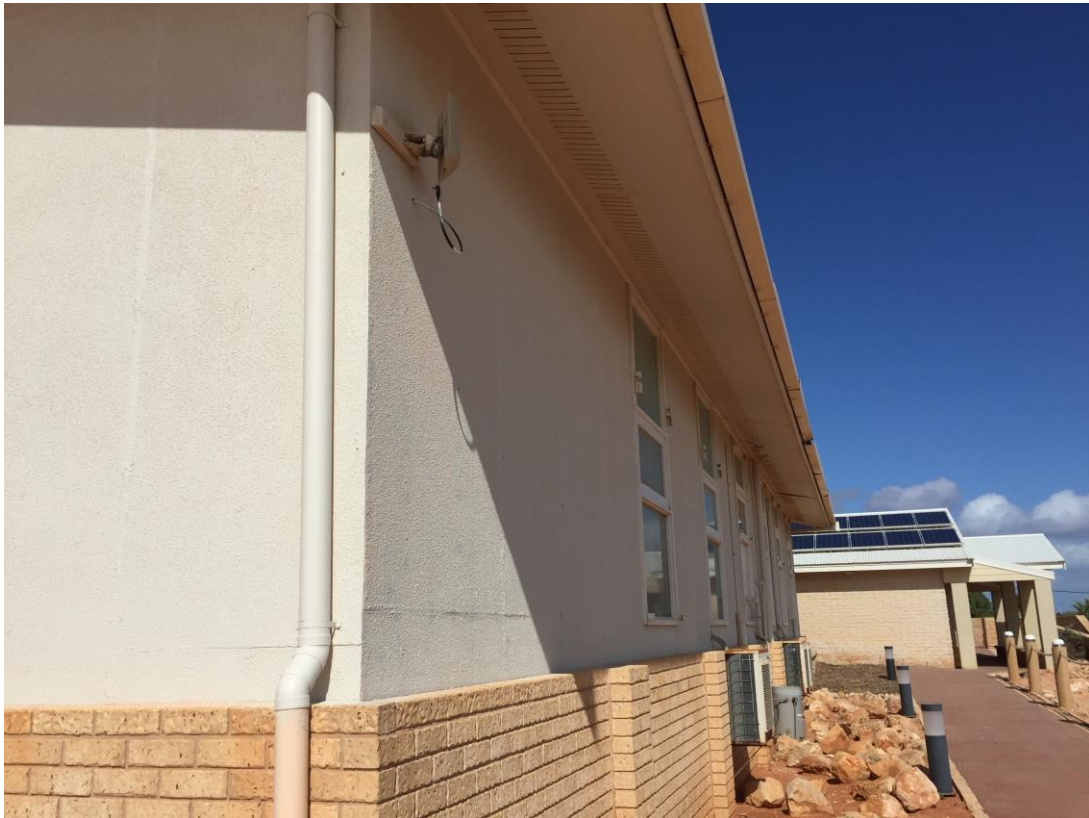
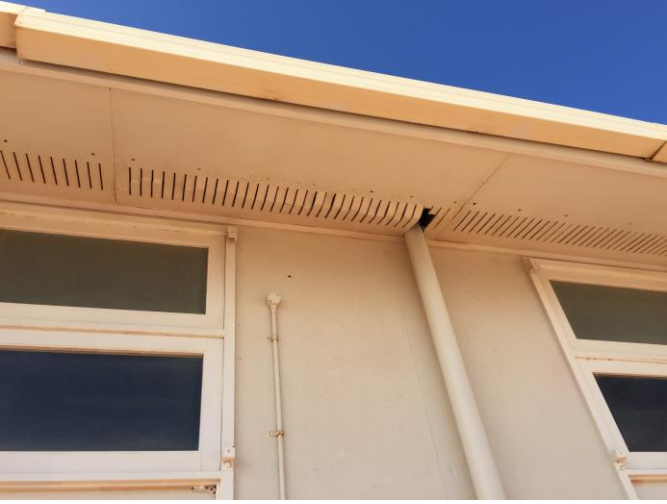
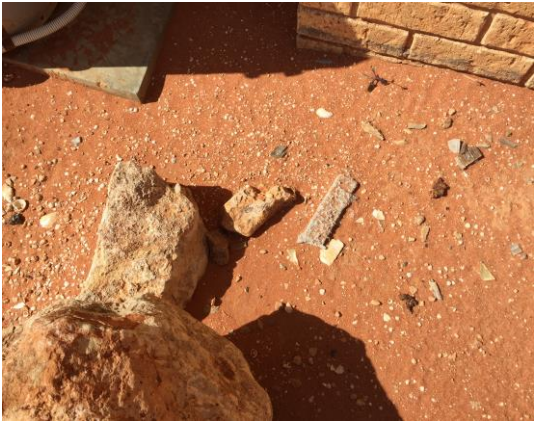
Location	Material	Condition	Potential for Disturbance	Control Measures
Roof and fascias	ACM	Fair to Good – Roof sheets un-painted with no damage; fascias are painted to match gutters – no damage visible.	Low	Sealing the roof will prolong the life of the sheets.  Periodic inspection
Eaves	PACM	Mostly Good – painted – one section along the rear of the building where the vented eave material has dropped and bent and <b>2 slats have broken off and several other slats are cracked, plus a sheet end has dropped slightly a short distance away and needs to be re-secured</b> , possibly due to rain running down the wastewater vent pipe through the roof seal and affecting the eave or from movement of the PVC vent pipe in strong winds.  <b>A few pieces of broken ACM are on the ground.</b>  <b>Little more deterioration has occurred over the last 2 years.</b>	Low	The section of vent pipe protruding above the roof is PVC material so the water leak may have been resolved. No evidence of moisture from recent rains. <b>Vent pipe needs to be secured to stop it moving about in the wind and possibly breaking more of the eave material. Advisable for these sections of vented eave material to be replaced with new eave lining.</b>  <b>The pieces of broken ACM should be picked-up, wrapped, and disposed of.</b>  Periodic inspection

External Walls	PACM	Good – painted – no visible damage.	Medium	Periodic inspection
Sections of Gutters and Downpipes	ACM	Good – painted – guttering along rear is now metal and 2 downpipes have been re-directed to the sides of the	Low	Seal un-painted end of downpipe and install new PVC length of

building and the old ACM downpipes have been removed only leaving a small section in place above the brick work which has been filled with concrete and painted; one downpipe is missing at the front of the building and the top of the downpipe section is unpainted but not damaged.		downpipe. Periodic inspection
Wastewater Vent Pipe	ACM	Good – painted – no visible damage.	Low	Periodic inspection
Internal Walls	PACM	Good – painted – no visible damage.	Medium	Periodic inspection
Switchboard	ACM & Zelemite	Fair – ACM line inside of timber switchboard box, unpainted with cut edges and fraying along bottom.  Good – Zelemite in which switches are installed.	Low  Low	Seal cut edges. Periodic inspection

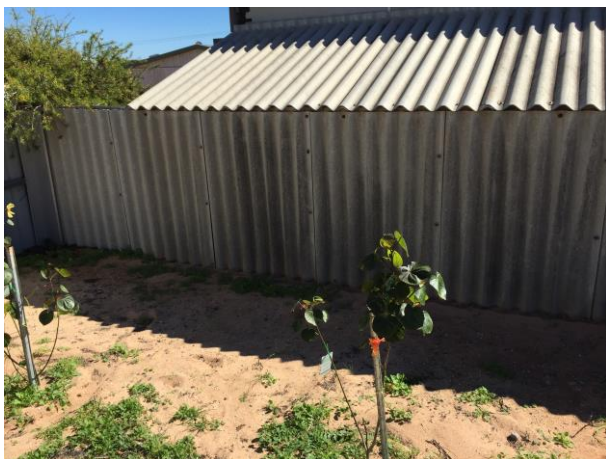
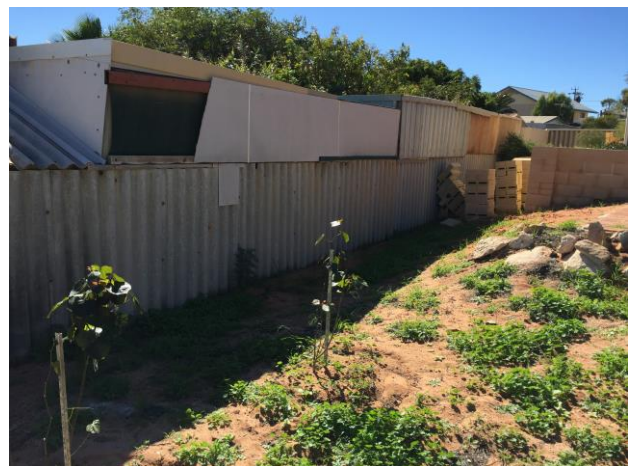
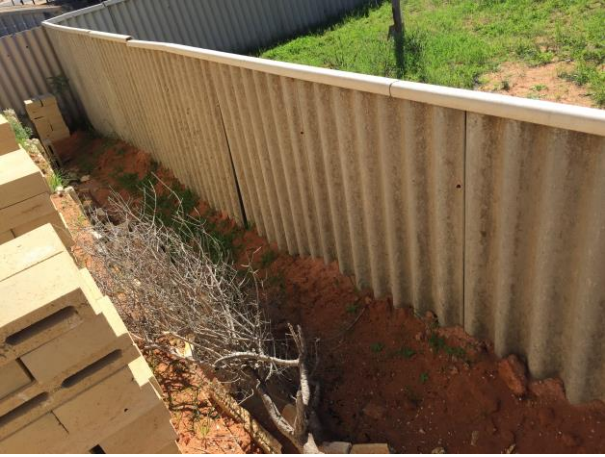
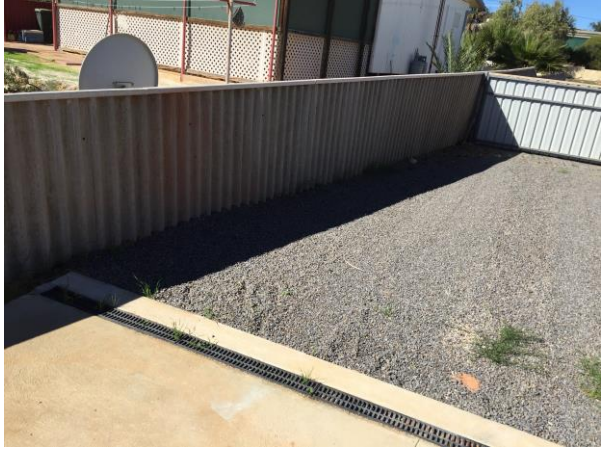
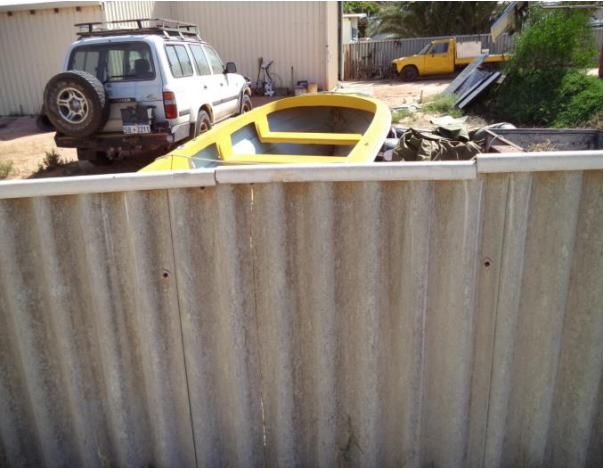
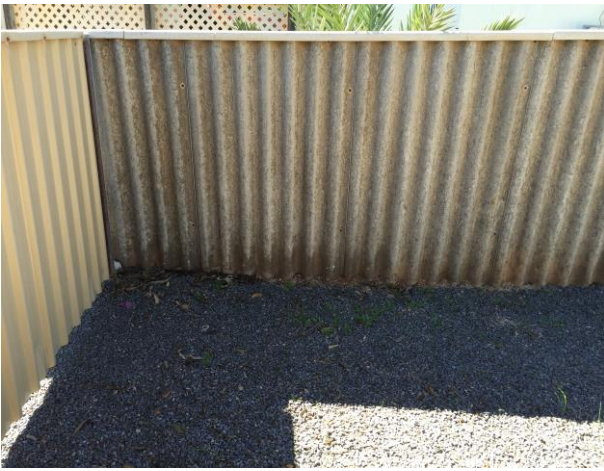
Location	Material	Condition	Potential for Disturbance	Control Measures
Boundary Fence listed below	ACM	Generally good	High	Seal damaged sections Requires periodic inspection.
North (rear) fence		Un-painted with no capping – a few sheets have small broken sections at the top of them		As above – neighbour at rear has built on fence line which is probably the reason for the damage.
East (side) fence with capping		Un-painted sheets and capping – one sheet cracked (vertical); 2 sections of capping are broken adjacent to neighbour's palm, 2 whole sections that had broken from main length of capping.		As above – suggest or ask neighbour to cut back palms to clear fence. Requires periodic inspection.

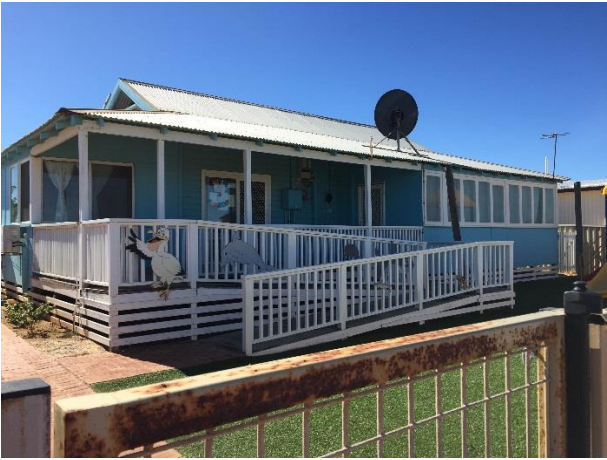
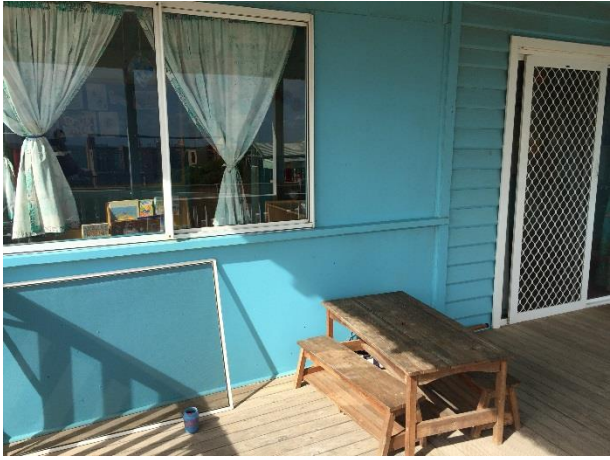
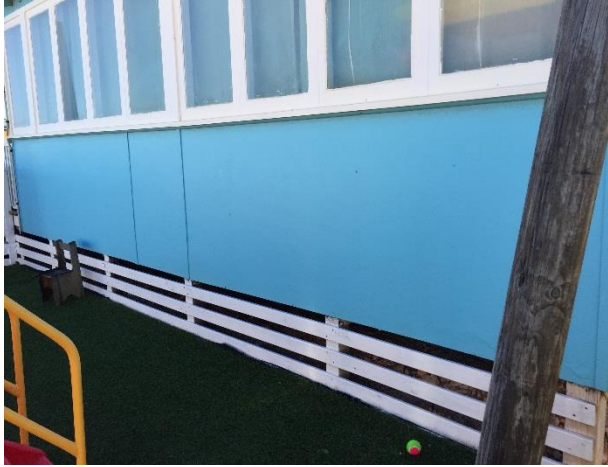
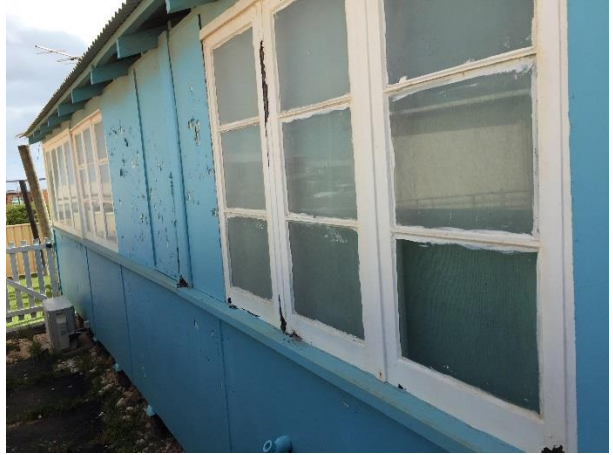
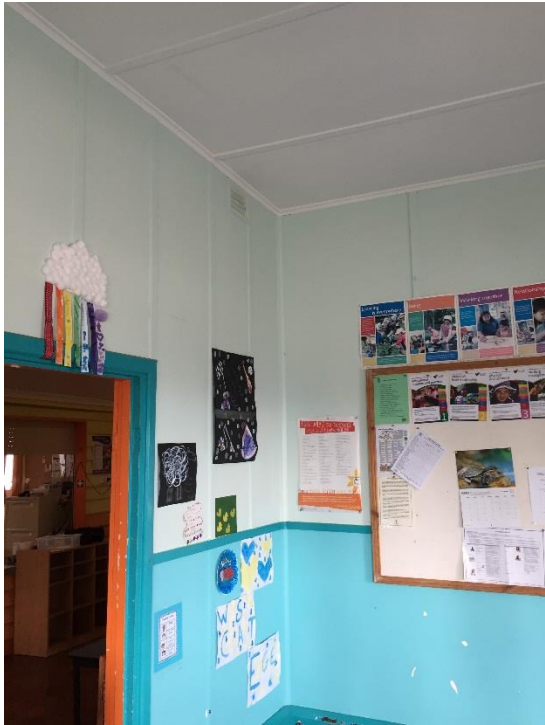
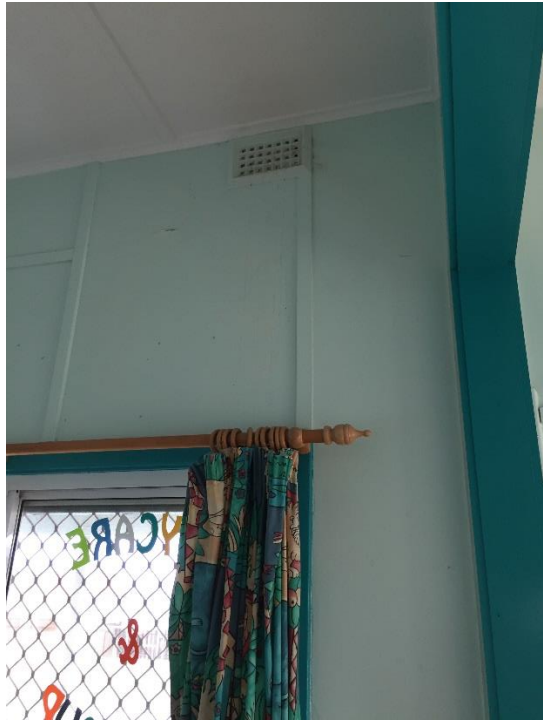
Location	Material	Condition	Potential for Disturbance	Control Measures
Sections of external walls	ACM	Good to Fair – Painted; on south side paint is peeling and bubbling due to moisture getting in behind paint	Medium	Periodic inspection  <b>Treatment of wood rot in timber window frames and sheet batten would also help</b>
Sections of internal walls	PACM	Good to Fair – Painted; 3 areas where paint has bubbled due to moisture but it is still whole; 2 sheets left side of kitchen roller door over server cracked in 2016 possibly due to machinery demolishing the old Ambulance Centre situated behind the Child Care Centre, plus there are more sheets along back wall of kitchen where cracking in sheets is visible but has not broken through the paint surface; repairs to openings around new wall split air-conditioners done with new materials.	Medium	Periodic inspection  <b>Cracks in wall sheets next to roller door should be filled and repainted to prevent any AC fibres becoming airborne</b>

Ceilings	PACM	Good – Painted; there is 1 or 2 areas where the paint is flaking.	Low	Periodic inspection  <b>In main room replace missing sheet cover strip and re-install bulb light fitting that has replaced fluoro light fitting.</b>

Vinyl floor sheeting	PACM	Good – Vinyl surface has no tears, cuts, or holes – backing is not exposed – does not look to be old vinyl so likelihood of ACM is low.	Medium	Periodic inspection
Wastewater vent pipes (x2)	ACM	Good	Low	Periodic inspection <b>Should paint the sections above the roof line to preserve the AC material</b>
Switchboard (part)	ACM and Bakelite	Fair – ACM line inside of timber switchboard box, un-painted with cut edges.  Good – Bakelite in which switches are installed.	Low  Low	Seal cut edges.  Periodic inspection
Fence in sections	Some sheets ACM, rest cement sheeting	Fair – holes and cracks in sheeting have been painted on both sides (except on neighbour's east side fence), and except for rear internal fence between shed & cream metal fence where capping has been removed & one top corner has been broken.	High	Periodic inspection, but ideally it should be replaced.

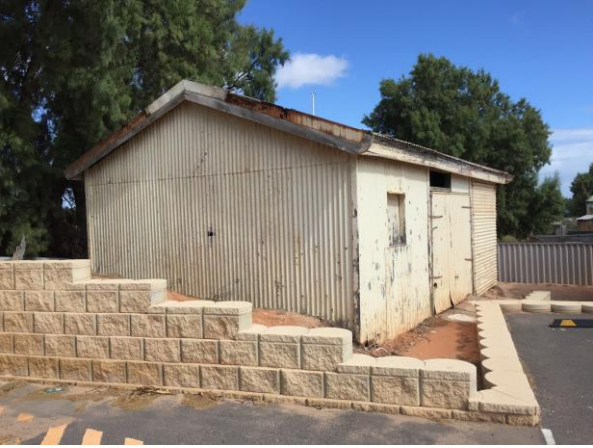
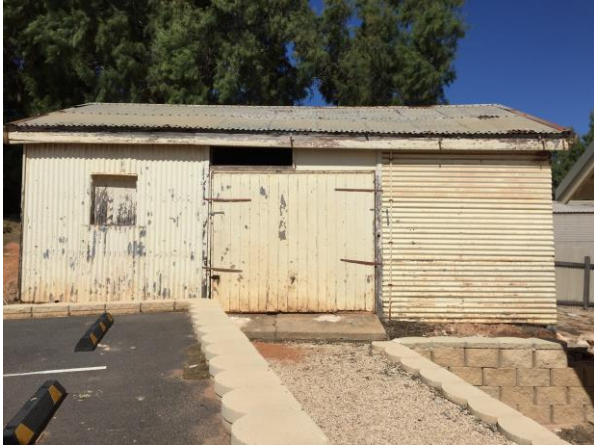
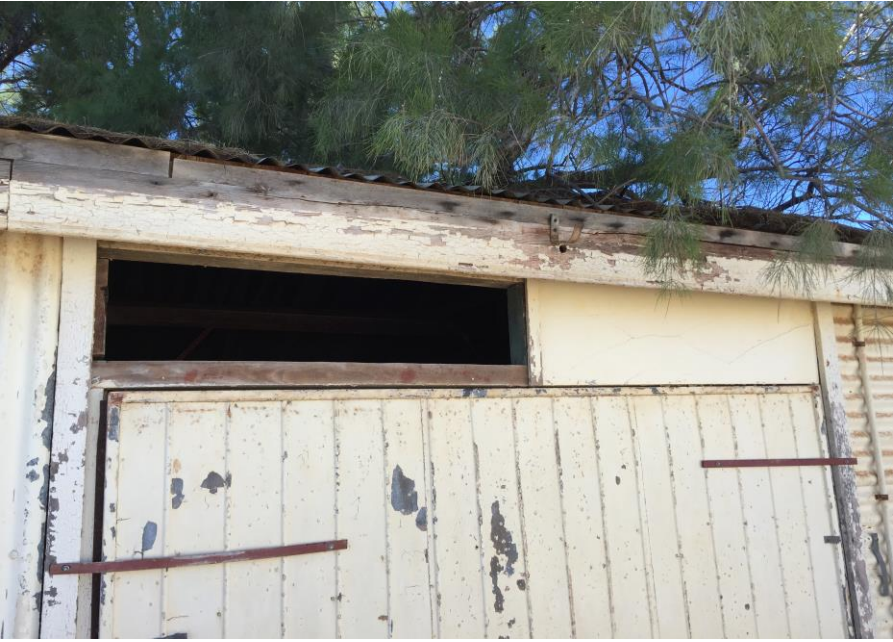
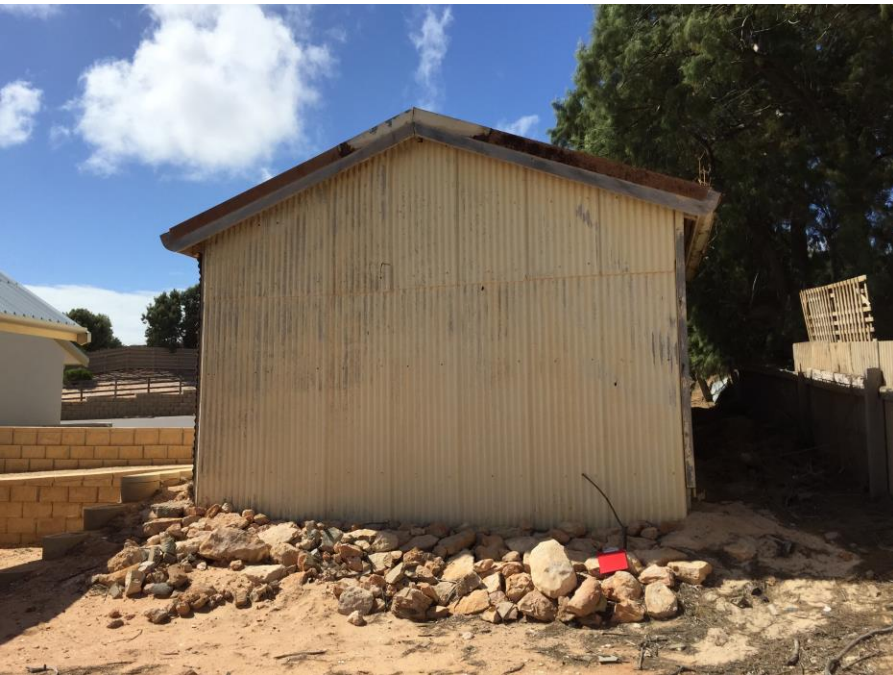
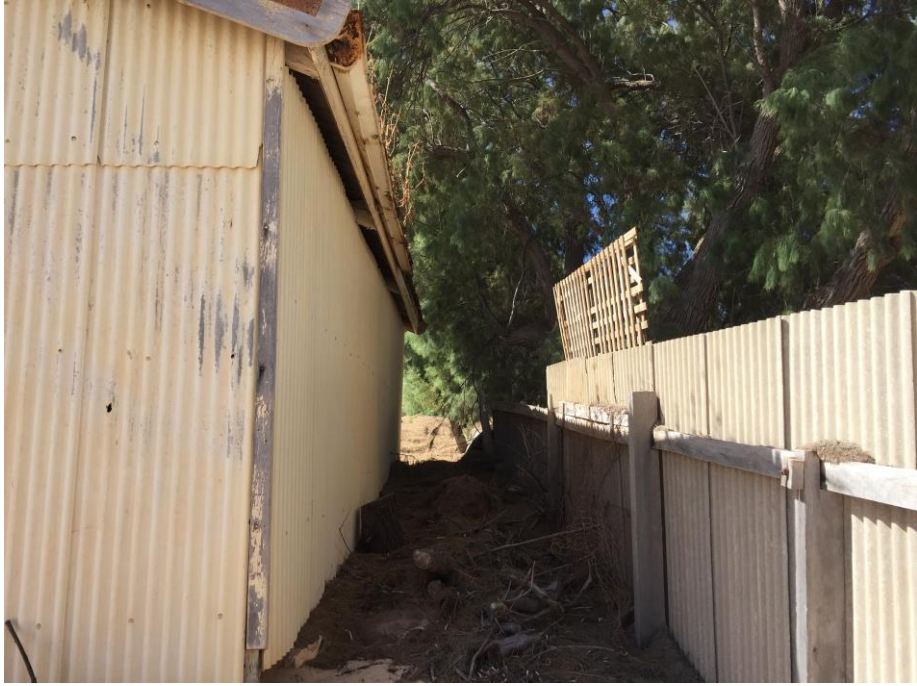
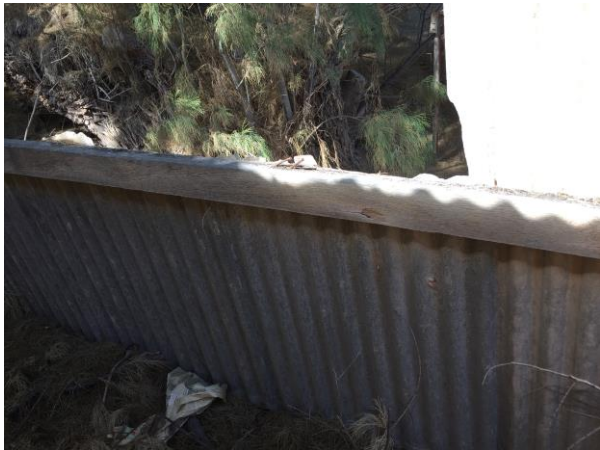
Location	Material	Condition	Potential for Disturbance	Control Measures
Gutter	ACM	ACM guttering has been removed from along the front of the building. Section of rear guttering is metal.	N/A	<b>None required as no ACM guttering left.</b>
Sections Wall above Door	PACM	The left hand section which previously had a hole in it has been removed, and the right hand section is cracked through the paint surface.  <b>No change occurred.</b>	Medium	Replace the whole section of wall above the door to make the building more weather-proof.
Side Fence (south)	PACM	Section of fence behind the Old Outhouse has <b>numerous</b> sheets broken, some of the fence has been removed, and the rest is in good condition – un-painted.  <b>There are a few small pieces of broken ACM on the ground S side of the building.</b>	High	<b>Due to the number of broken fence sheets and the number already removed or snapped off at ground level, this side fence should be replace sheets with cement sheeting or other type to define boundary and provide privacy for neighbour.</b>  <b>The broken pieces of ACM on the ground should be picked-up, wrapped, and disposed of.</b>

Due to the condition of building demolition should be considered or repairs undertaken to make building safe. **While the large tree branch from neighbouring property has been cut off, there are other overhanging branches that could fall on to building and damage it.**

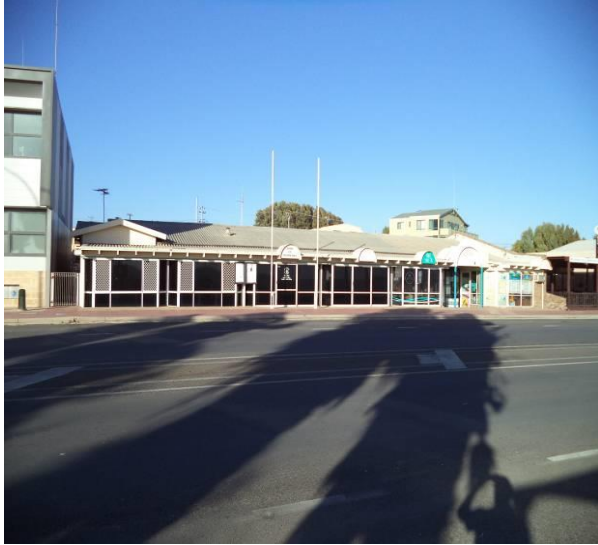
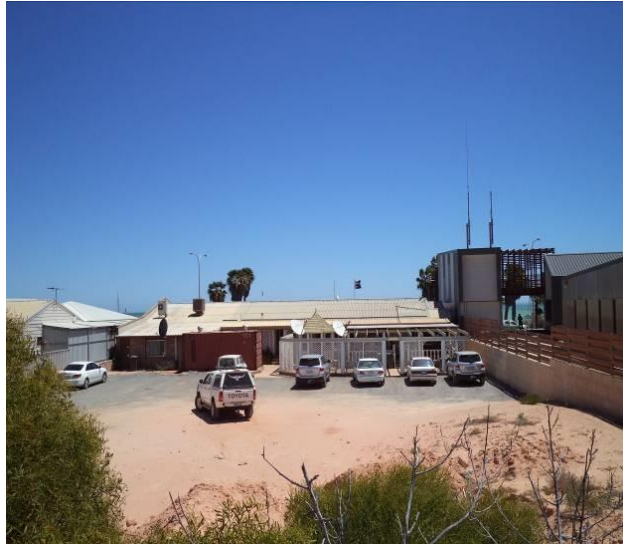
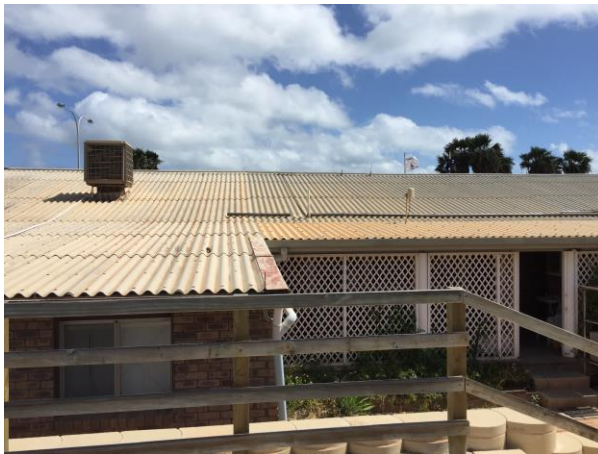
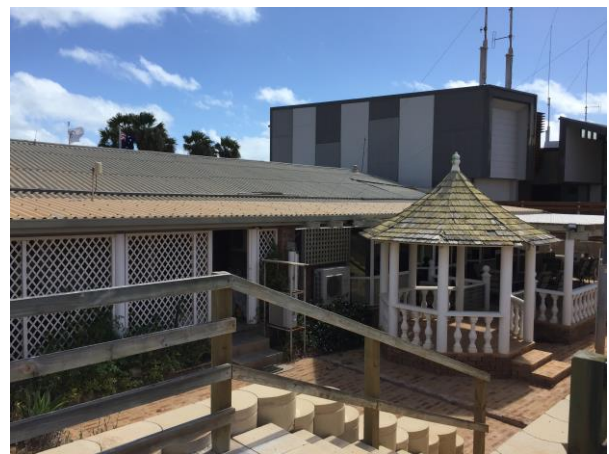
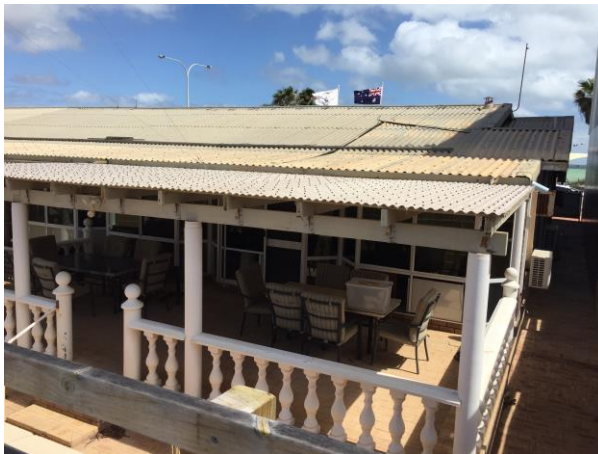
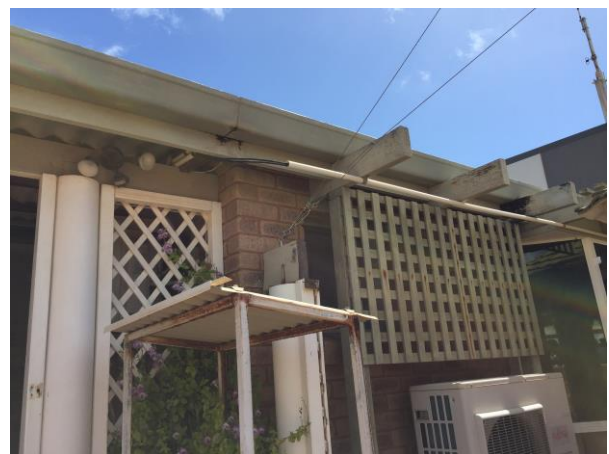
Location	Material	Condition	Potential for Disturbance	Control Measures
Roof and fascias	ACM	Fair – roof sheets and ridge are un-painted but in fair condition; fascias are painted red or cream to match guttering or brick colour – a few broken ends which are un-sealed plus a few cracks in fascias.	Low	<b>Seal roof &amp; ridge, and re-paint fascias (including edges) to preserve AC material.</b> Otherwise seal broken ends of fascias and re-seal over cracks, otherwise replace when replacing guttering or re-roofing.  Periodic inspection
Sections of Eaves	PACM	Good in the main, painted – one damaged section on north-east corner of building next to new fiber cement column.	Low	Remove and replace damaged section of eave.  Periodic inspection
Gutters & sections of Downpipes	ACM	Fair to Good – outside of guttering is painted but the inside is un-painted. Paint is beginning to flake in places, and there are 2 join leaks along the rear (east) of the building. ACM gutter brackets also have paint flaking. Downpipes painted and are in good condition.	Low	Repair leaking gutter joins, spray guttering and gutter brackets with a sealer (eg Bondcrete & water or <b>bitumen product</b> ) and re-paint when dry inside and outside.  Periodic inspection

Wastewater Vent Pipe	ACM	Good - painted	Low	Periodic inspection
